CONNECTICUT RIVER BASIN  
ALSTEAD, NEW HAMPSHIRE

VILAS POOL DAM

PHASE I INSPECTION REPORT  
NATIONAL DAM INSPECTION PROGRAM

DECEMBER 1979

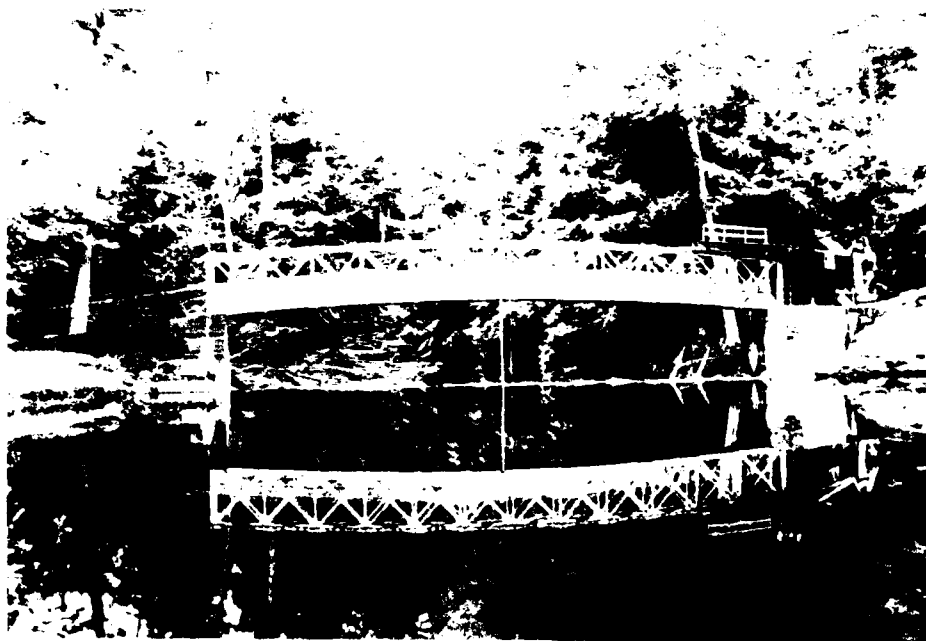
Overview from upstream side

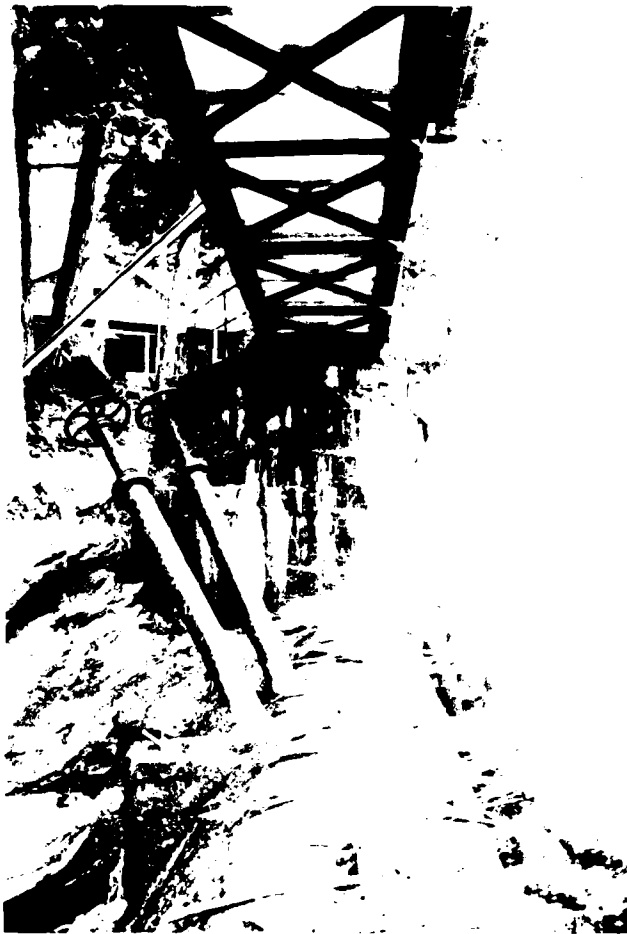
5. Crest and right abutment  
showing hand wheel controls  
for the two 24 inch gates
